NASA TECHNICAL NOTE

NASA TN D-8411

EFFECT OF LOW-VELOCITY IMPACT DAMAGE ON THE COMPRESSIVE STRENGTH OF GRAPHITE-EPOXY HAT-STIFFENED PANELS

*Marvin D. Rhodes, Jerry G. Williams,
and James H. Starnes, Jr.*

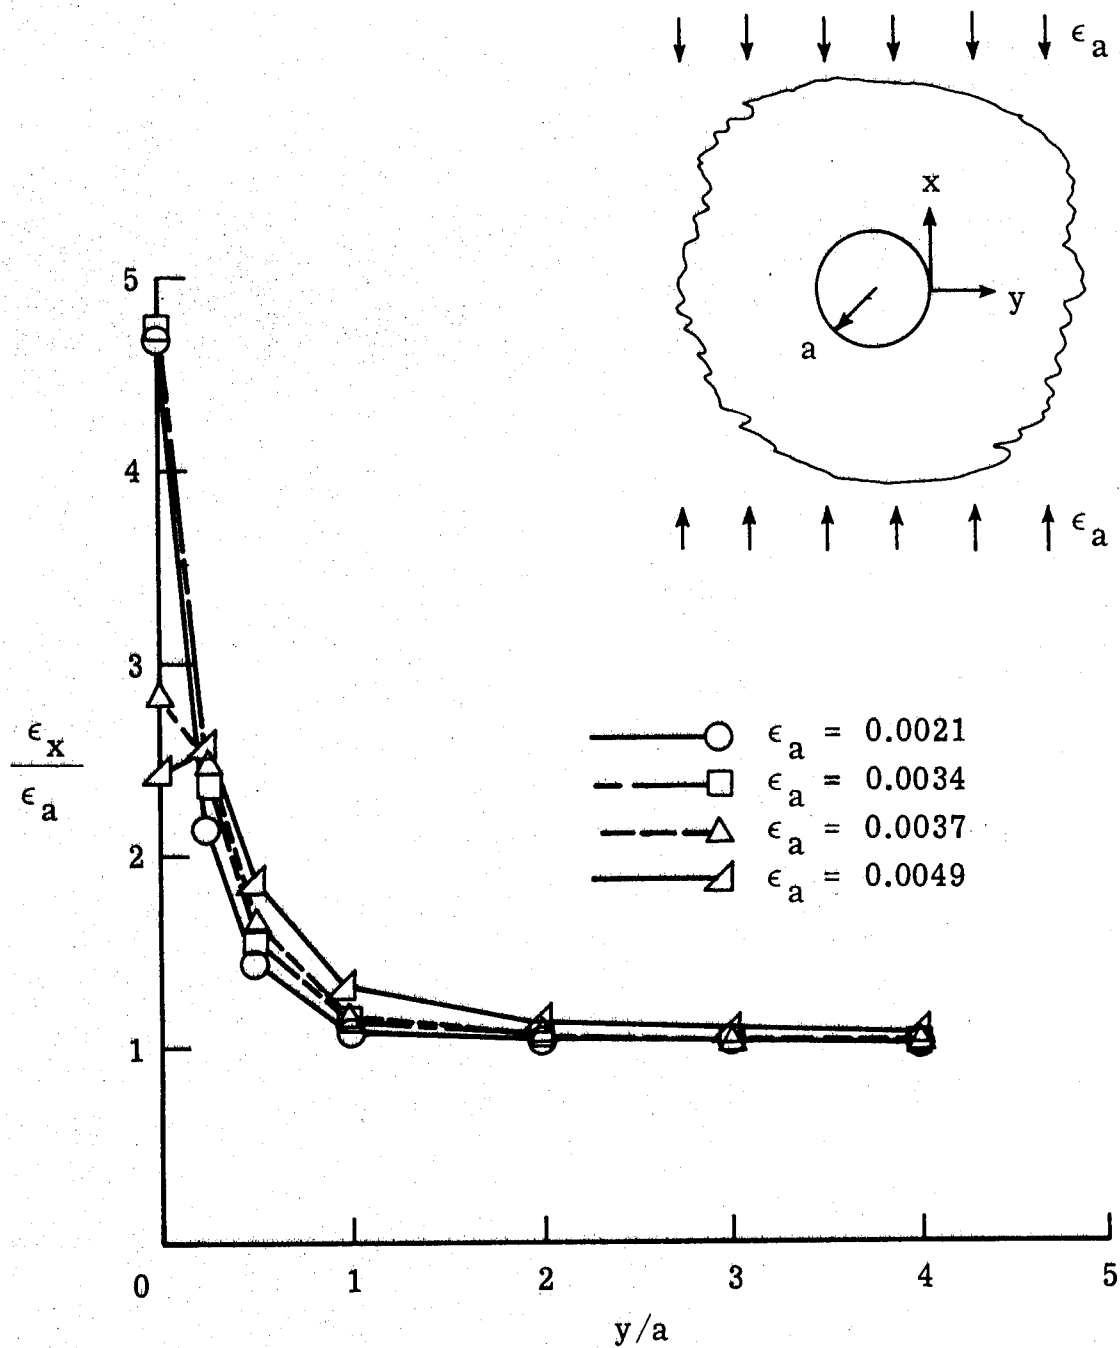
Figure 5.- Strain measured in vicinity of 1.27-cm-diameter cutout on panel B5 (ϵ_x denotes measured strain at indicated location at applied axial strain ϵ_a).

cutout and one gage was located on the cutout free-edge surface. The distribution of strain as determined by these gages across the right side of the panel normalized by the applied strain is shown in figure 5. The strains are several times greater near the cutout edge than those 3 cutout radii away and there are steep strain gradients near the cutout edge. Up to an applied strain of about 0.0034 the strain at the cutout edge is approximately 4.6 times greater than the far-field strain. At an applied strain of 0.0034 the strain at the cutout edge was initially 0.016 and then dropped suddenly to 0.012. It is suspected that a local material failure occurred at this very high strain level. At applied strains between 0.0034 and 0.0049 the strains at the cutout edge were only 2.4 to 2.8 times as great as the far-field strains as indicated by the results shown in figure 5.

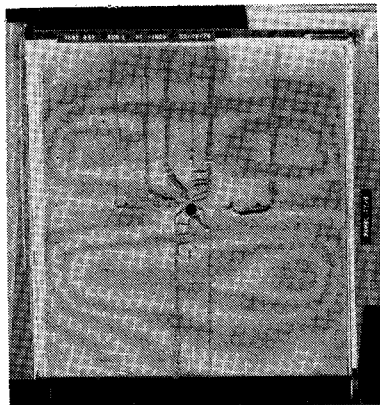
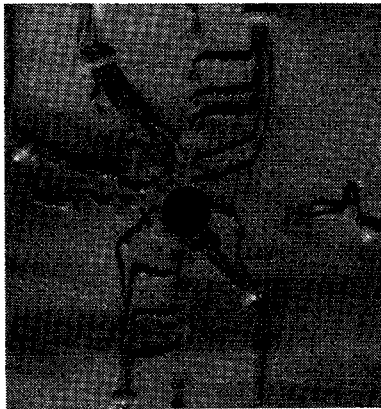
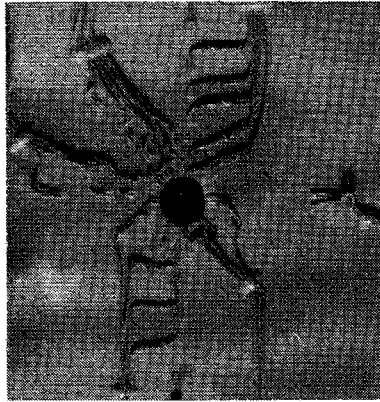
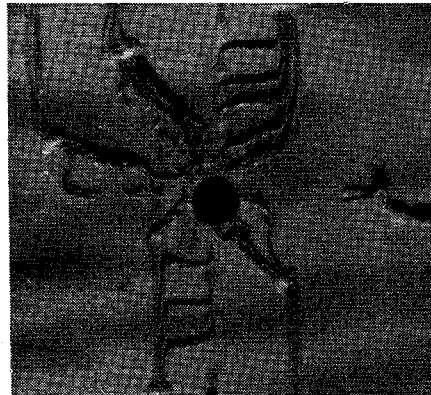
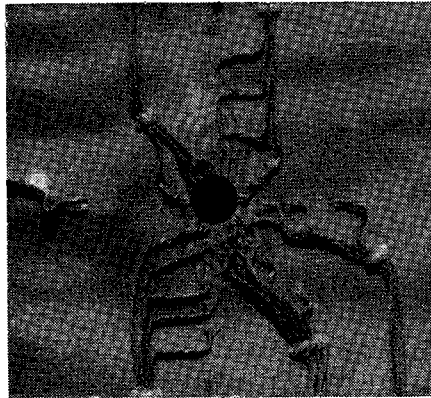
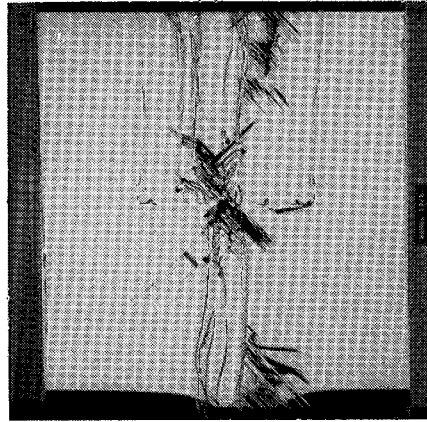
Figure 6.- Photographs of moiré-fringe patterns of panel B5 at several values of applied axial strain ϵ_a .
L-77-143

At applied strains near 0.0049 large changes in strain were recorded near the cutout and noticeable panel displacements began to develop in the vicinity of the cutout. Moiré-fringe patterns representing the normal displacement field near the cutout are shown in figure 6 for several values of applied strain. A representative moiré-fringe pattern for an applied strain of 0.0048 is shown in figure 6(a) and a closeup of the cutout region for this applied strain is shown in figure 6(b). At an applied strain of approximately 0.0049 a local buckling displacement field began to develop at the cutout edge about 60° counterclockwise from the loading axis. This displacement field was about 1.0 cm long for an applied strain of 0.0050 and is shown in figure 6(c). As the applied strain was increased, the extent of the displacement field increased to a length of about 1.8 cm for an applied strain of 0.0055 as shown in figure 6(d). At an applied strain of 0.0057, the displacement field had rotated counterclockwise to a position 90° from the loading axis (fig. 6(e)) and extended on both sides of the cutout. This displacement field extended about 2.5 cm on the left side and about 2.4 cm on the right side of the cutout which makes the total length of this displacement field approximately equal to the width of the 0° fibers in the skin under the stiffener. The local displacement field propagated across the panel (fig. 6(f)) at an applied strain of 0.0058 which indicates that the local behavior precipitated panel failure.

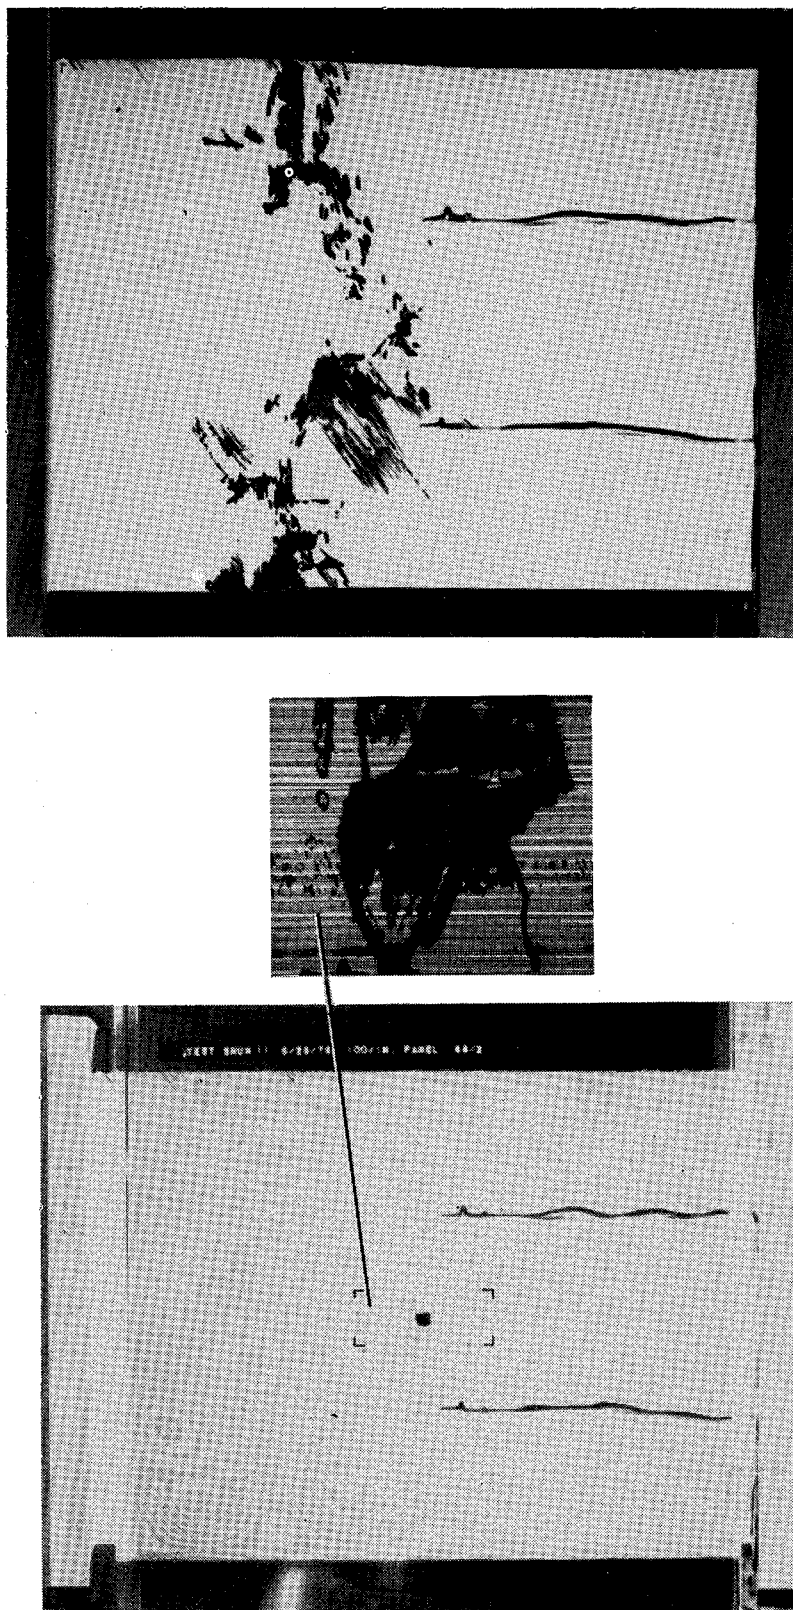
Figure 7.- Panel A4 (after impact in high-axial-stiffness region while at zero applied axial strain) before and after failure.

Photographs of the moiré-fringe pattern of panel A4 loaded prior to failure and of the failed panel are shown in figure 7. The moiré-fringe pattern (fig. 7(a)) is similar to that of the undamaged panel A1 (fig. 3(a)). The dark

spot in the center of the panel is the impact location where the paint has been removed for post impact inspection. Figure 7(b) indicates that the panel failure region is extensive and includes the impact location. The panel was inspected ultrasonically prior to failure, and a photograph of the oscilloscope record for the region in the vicinity of the impact location is shown in the insert of figure 7(a). The area represented by the insert is outlined on the photograph. The dark area shown in the insert indicates subsurface damage in the panel. This area is about 6.35 cm long and about as wide as the region beneath the hat which contains 0° plies. The results of tests on panels A4 and A5 were similar and both panels failed at applied strains near their design strain level (0.0034).

(a) Photograph of moiré-fringe pattern of buckled panel at applied axial strain of 0.0035. Insert shows region of subsurface damage.

(b) Panel after failure.

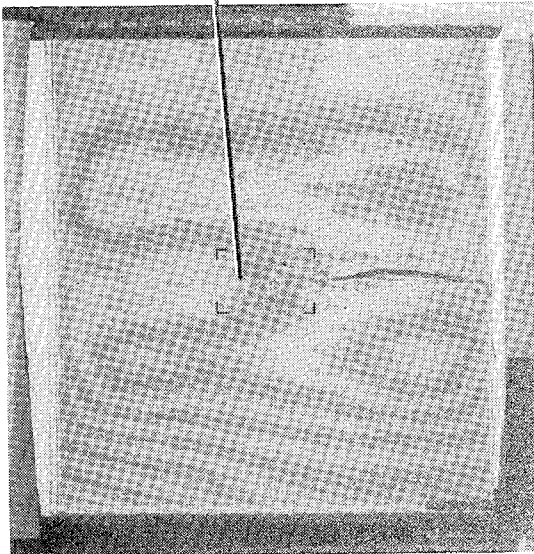
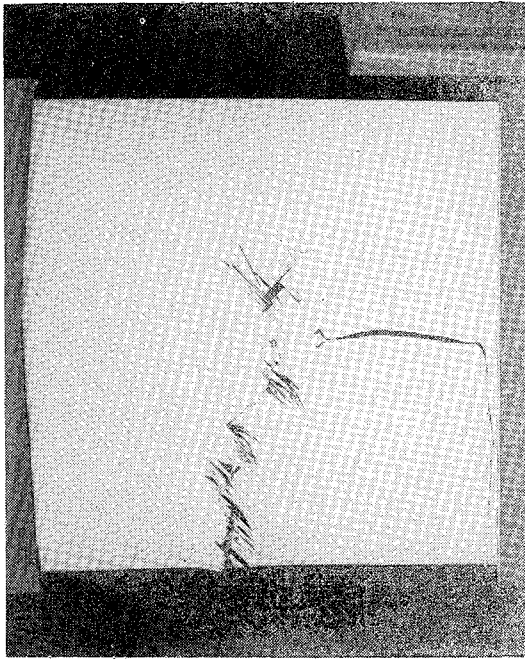
Figure 8.- Panel B6 (after impact in high-axial-stiffness region while at applied strain of 0.0003) before and after failure.

Photographs of the moiré-fringe pattern prior to failure and of the failed panel B6 are shown in figure 8. A small circular pattern in the region of impact was observed with the moiré-fringe technique indicating the presence of local damage. The development of this fringe pattern and an examination of the panel failure indicate that the impact damage precipitated the panel failure. Failure occurred at an applied strain of 0.0043 which is about 54 percent of the design value.

(a) Photograph of moiré-fringe pattern at applied axial strain of 0.0041 showing development of fringe pattern near point of impact. Insert shows region typical of subsurface damage in similar test panel.

(b) Panel after failure.

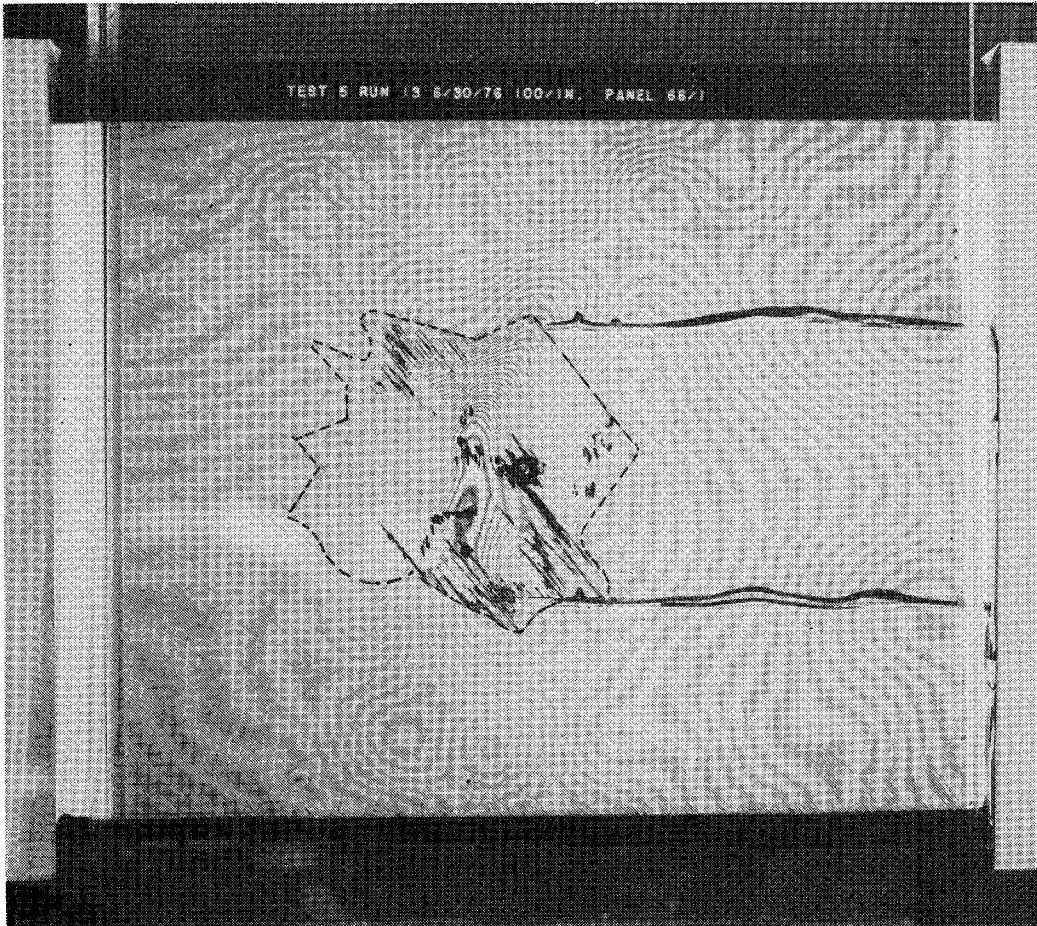
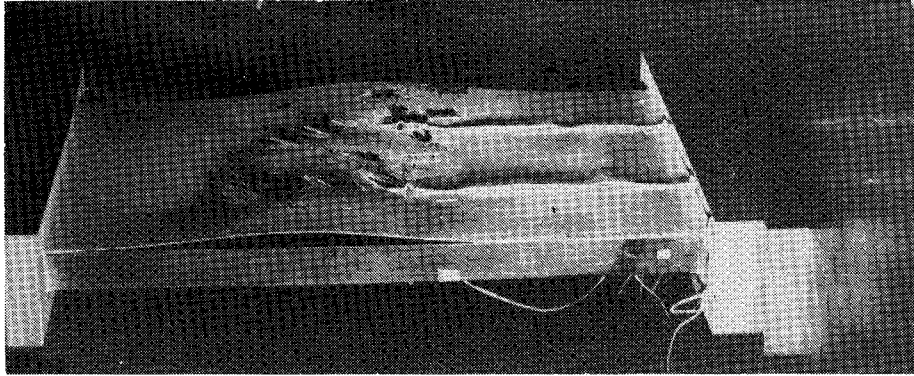
Figure 10.- Panel A3 (after impact in high-axial-stiffness region while at applied strain of 0.0034) before and after failure.

High axial strain at impact: Test panels A3, B7, and B8 were damaged by impact with a high axial load applied. (See table II.) Panels A3 and B7 which had an applied axial strain of 0.0034 and 0.0030, respectively, had a large region of visually detectable damage in the impact area. Instrumentation monitoring applied load indicated both panels had significant load reductions at impact due to loss in panel stiffness (table II). Both were subsequently loaded to failure to determine the panel residual strength. Panel A3 was ultrasonically inspected prior to the residual strength test and an extensive region of subsurface damage was detected. A photograph of the moiré-fringe pattern of the panel loaded prior to failure is shown in figure 10(a) where the subsurface-damage region is outlined. Even though the damage in panel A3 is extensive, it buckled at an applied strain near the design level and carried additional load after buckling similar to the undamaged panels. The panel failed in the region of the impact damage (fig. 10(b)) at an applied strain of 0.0037. Comparison of panel A3 with panels A4 and A5, all of which were designed for a load of 0.53 MN/m at an axial strain of 0.0034, indicates that

(a) Photograph of moiré-fringe pattern of buckled panel at applied axial strain of 0.0031.

(b) Panel after failure.

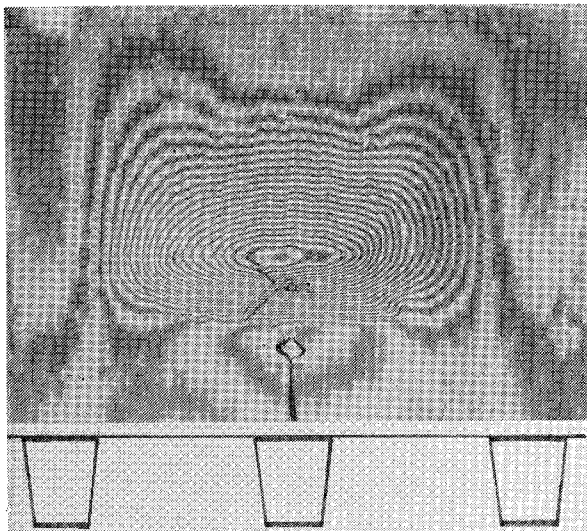
Figure 11.- Panel B7 (after impact in high-axial-stiffness region while at applied strain of 0.0030) before and after failure.

Several photographs of the moiré-fringe pattern taken during the residual strength test of panel B7 are shown in figure 11 along with a photograph of the failed panel. The moiré-fringe pattern shows considerable lateral deformation of the panel center, which may be due to impact-induced delamination or skin buckling. When the panel was damaged by impact, a reduction in applied load of 28.9 kN was measured. The 28.9-kN load reduction approximately corresponds to the load which the high-axial-stiffness region beneath the center stiffener is calculated to carry for an imposed strain of 0.0030. The panel failed at an applied strain of 0.0046 which is 58 percent of the design value.

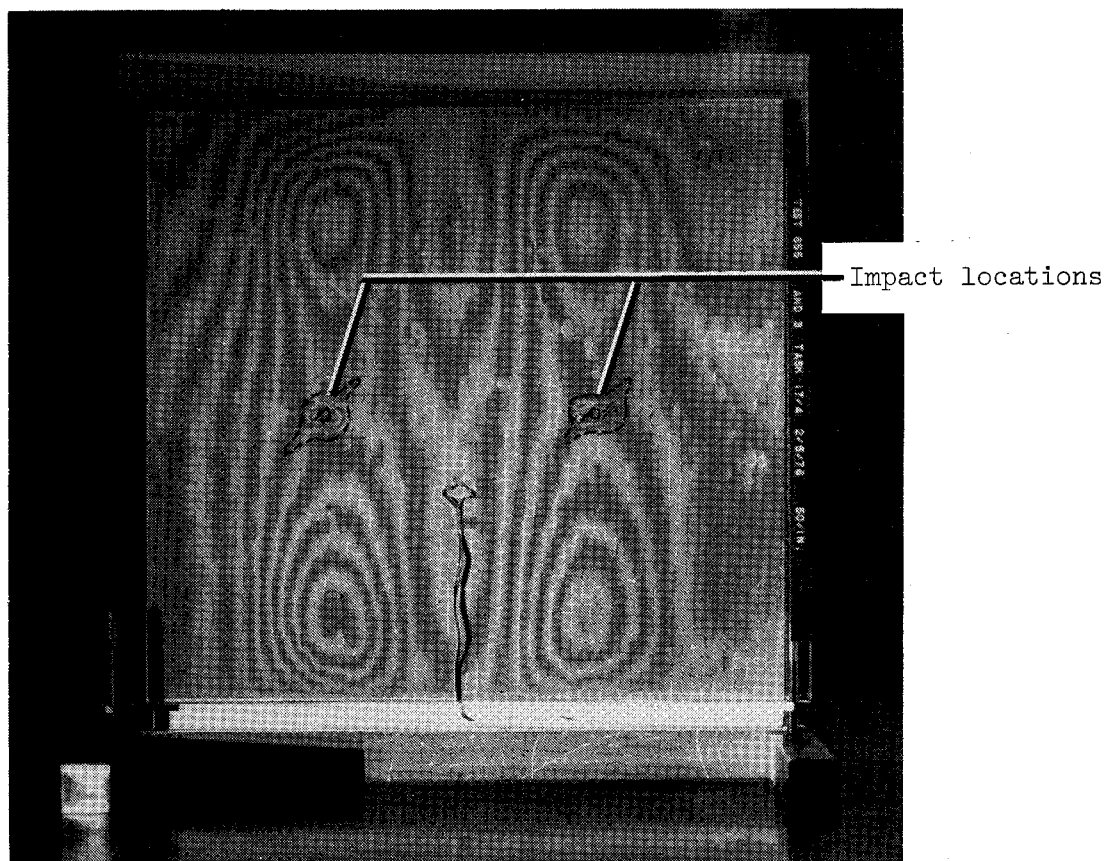
L-77-149
Figure 13.- Photograph of moiré-fringe pattern for panel B9 at applied axial strain of 0.0062 with impact damage at two locations in low-axial-stiffness region.

Impact damage in the low-axial-stiffness region.- In order to evaluate the effect of damage in the angle-ply, low-axial-stiffness region, panel B9 was damaged by impact in the skin region between stiffeners ($\pm 45^\circ$ for the design B panels). The panel was loaded to an applied axial strain of 0.0040 when impact occurred. (See table II.) No reduction in the applied load upon impact was observed and no increase in axial strain was noted in the gage near the point of impact. Although some local fiber failure and delamination was observed, the failure did not propagate. After impact the panel was loaded to an applied strain of 0.0054 without propagation of local damage. At this load the panel was damaged in the remaining $\pm 45^\circ$ skin region between stiffeners. (See table II.) No loss in load nor increase in strain near the point of impact was detected. This panel was subsequently loaded to an applied strain of 0.0062 at which a moiré-fringe pattern was observed in the end regions (see fig. 13) similar to that observed for the undamaged test panel. A local fringe pattern can be seen in the figure at each impact location.

Following this test the panel was inspected ultrasonically to evaluate the extent of the damaged region. The subsurface-damage region is outlined on the panel in figure 13. The two damaged regions are about the same size, which indicates that the magnitude of the applied strain had no apparent effect on the extent of local damage. These results indicate that impact damage in the regions having high axial stiffness is significantly more detrimental than it is in regions of low axial stiffness.
